## PRELIMINARY GEOTECHNICAL ASSESSMENT AND TRIP REPORT

State Route 8 (Signal Mountain Road) from Palisades road to Shoal Creek  
Road near LM 16.1

Project No. 33000-4200-04

HAMILTON COUNTY

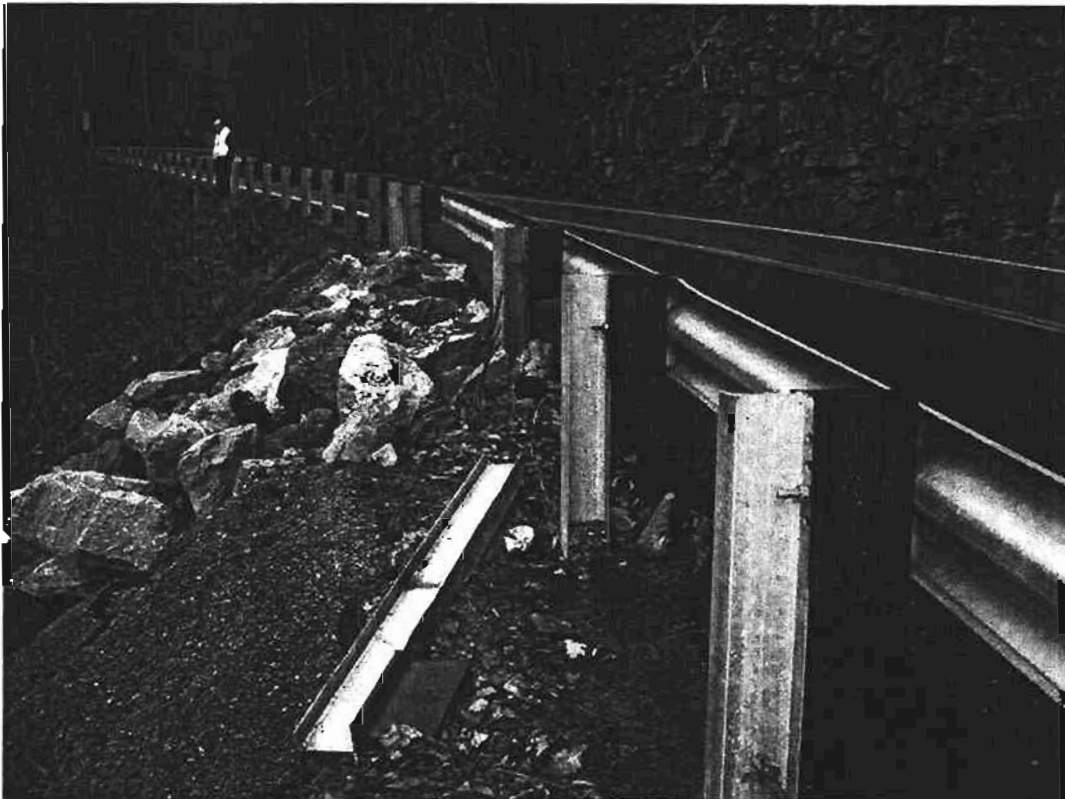
soil and rock from previous construction, rockfall, blasting or sliding. Approximately a 25 foot section, as measured along the roadway slipped and caused a reported 4 inch dip in the roadway. This area has been freshly patched by Region 2 Maintenance and the guardrail was repaired.

**Figure 1.** View of new sliding and patch along State Route 8 in the area near LM 16

The proximate cause of this problem was the too steep outside slope and poor drainage. This area has had previous problems as evidenced by the amount of limestone, pavement and gravel fill along the slope. There have been some fairly significant rain events in the past few weeks and this was a contributing factor to the slide. Seepage due to the rain adds an additional driving force. Maintenance has added additional asphalt to the side and some

additional large rock fill in an effort to stabilize the road. However, there is no firm foundation on the outside of the slope and this rock is expected to slide down the hill causing further problems. Additionally, there has been an increasing amount of water in the ditch along the site that has caused some water to get out onto and cross the roadway.

In the short term, the Geotechnical Engineering Section recommends that the new slide area be excavated using a track hoe, removing material on the outside slope and underneath the near traffic lane to as deep as feasible, expected to be approximately 15-20 feet. The excavated material would then be replaced with clean shot rock and repaved.

Additionally, the GES recommends that some drainage improvements be made to the area. Additional cross drains are recommended. However, these drains will need to be connected to downslope drains on the outside slope that lead downward to the stream below the roadway. These downslope drains will be needed to prevent concentrated water from eroding away an already marginally stable and in places unstable slope. Patching or reconstructing the drainage ditch along the upper side of the slope is also recommended. Water can seep through cracks in the drainage ditch, this seeping water puts additional stress on the roadway and can drive further sliding.

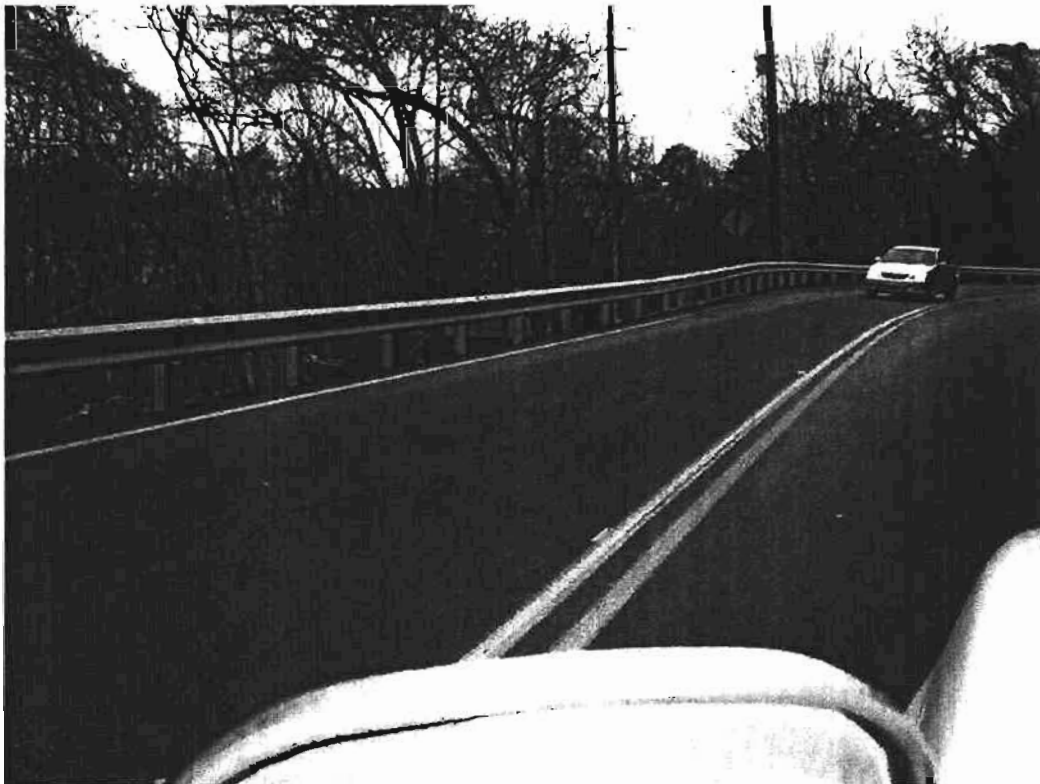
There are several areas of concern along State Route 8 starting just above LM 16 and extending downward to Palisades Road. There are several areas where previous sliding has occurred, and Maintenance forces have been regularly required to monitor and patch these areas. Several new slip areas were noted today and will be patched by another layer of asphalt.

**Figure 2.** View of new sliding along State Route 8 in the area of the “Space House Slide”

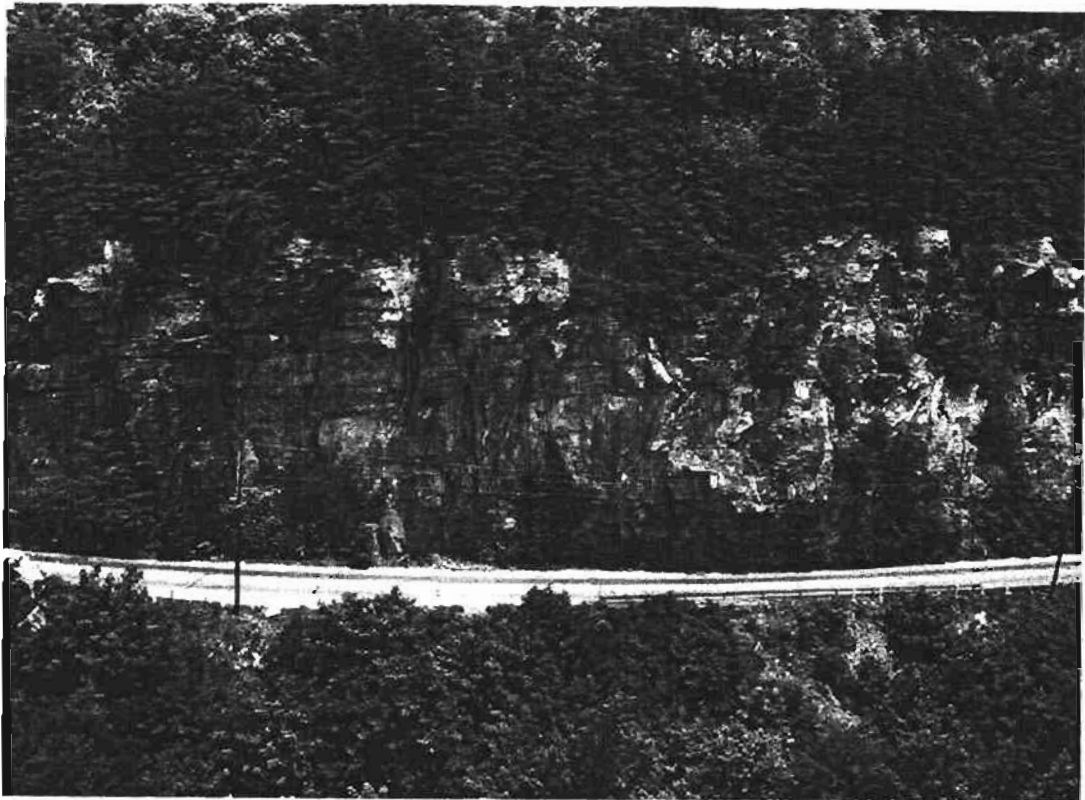
Additionally, a rockfall assessment has been performed of the rock cut along this section of roadway. This site has received an “A” rating and a score above 500, which puts it in the “High-A: Very High Risk” rockfall site category. This site is one of the 35 highest scoring sites for rockfall risk along state responsible roadways.

**Figure 3.** View of large rock cut along State Route 8 just below L.M. 16, aerial photo from 1982.

This site was rated highly due to the numerous areas along the rock cut that can contribute rockfall and because the roadway is right up against the rock bluff with little or no rockfall catchment ditch. Most rocks that fall off of this cut have no place to go but in the traveled way. The rockfall site assessment indicates that some large rocks (greater than 6 feet along and axis) can be

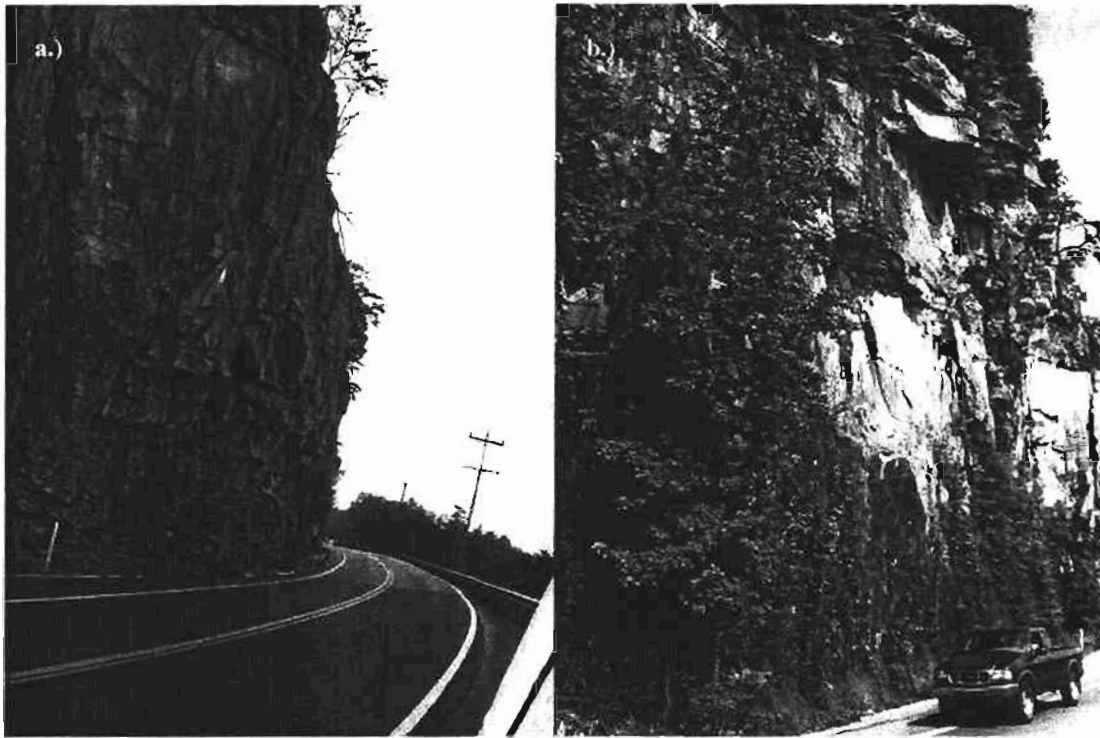
expected. Wintertime is a particularly problematic time for rock cuts of this type because of freezing and thawing of ice on the rock cut face which can pry rocks loose from the face and cause them to fall. Additionally, areas of overhanging rock are of particular concern.

Figure 4. Views of large rock cut along State Route 8 just below L.M. 16 taken a.) Jan 18, 2007 and b.) July 30, 2003.

The most obvious and unfortunately most expensive option is to re-cut the slope in the area of the rock cut and move the roadway further into the hillside onto more stable ground. This would have the effect of improving the rockfall hazard as well as preventing sliding of the roadway. This could be done for the portion of the roadway in the area of the rock cut. Other options will be required further down the hill as there are ancient landslides on the up-hill side of the road below the rock cut area. Previous investigation of the Space House slide area indicates that the addition of a properly placed MSE wall along with flattening of the slopes could provide significant relief in that area. Permanent slide repair options for the Space House Slide area have been developed and were submitted to TDOT Maintenance in 2004. Other options such as soil nailing, further retaining walls railroad rail cribbing, rock buttresses or and improvements in drainage can be investigated. If there are questions concerning this report, please contact the Geotechnical Engineering Section.
